UPDATING A TCU800 OVER USB

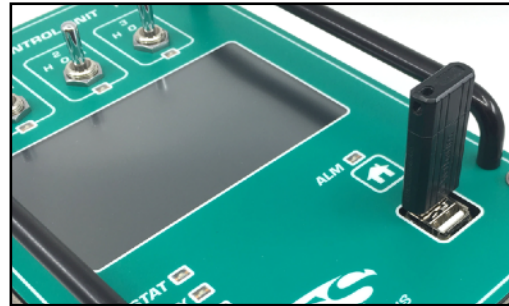
- 1 Insert the update USB into any free port on the front of the TCU800.

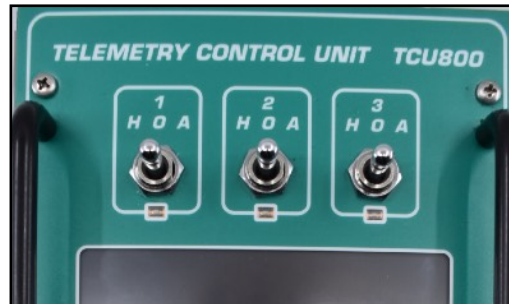
- 2 Place the HOAs into the off position.

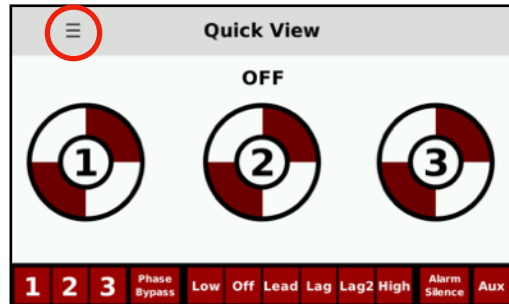
- 3 Tap the hamburger menu

in the top left of the screen.

If you do not see the

icon, tap anywhere on the screen once and it will appear.

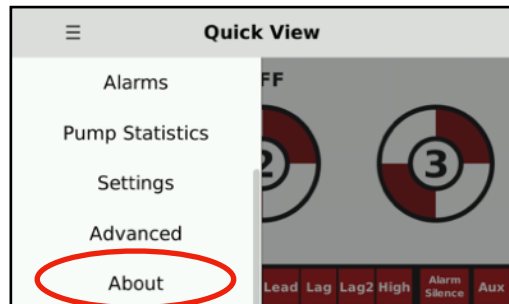
- 4 Tap **About**.

If you do not see this option, scroll down by sliding your finger up within menu pane.

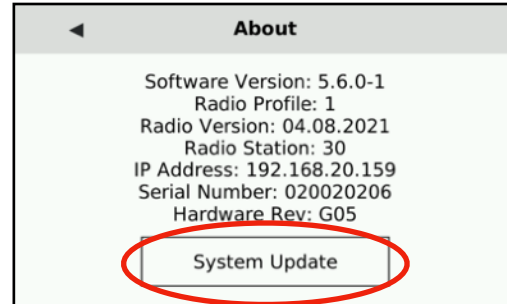
5 Tap **System Update**.

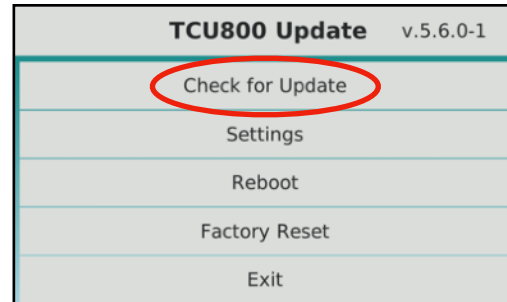
6 Tap **Check for Update** once the update screen has finished loading.

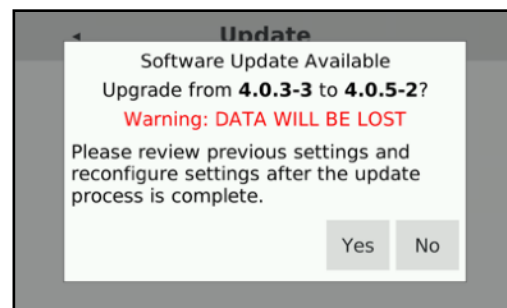
If you see this screen →
There is an update available.

Tap **Yes**.
Continue to step 8.

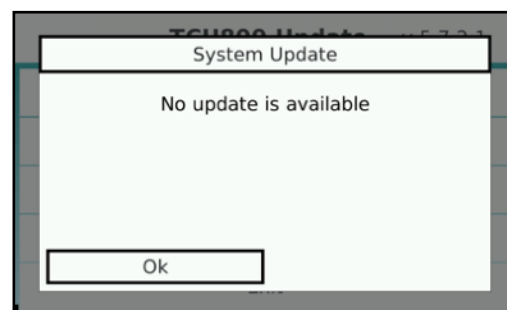
If you see this screen →
The TCU800 is up-to-date, or the update USB has not be setup properly.

Tap **Ok**.
Skip to step 11.

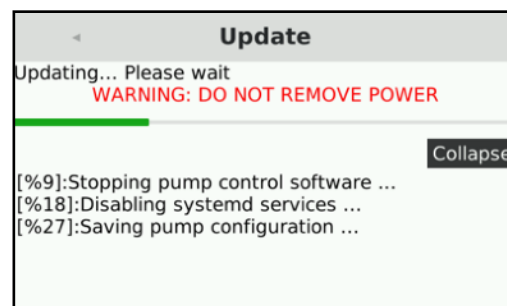
8 Wait for the update to complete.

The green bar shows the overall progress, while the scrolling text displays key milestones in the update.

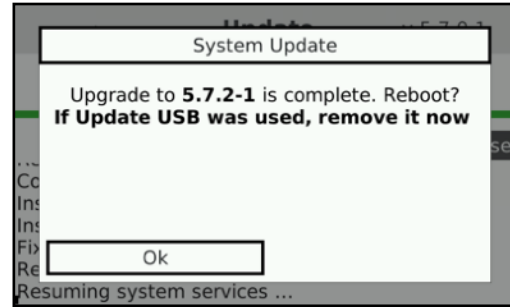
- 9 Wait for the screen indicating that the upgrade is complete.

The TCU800 will now reboot.

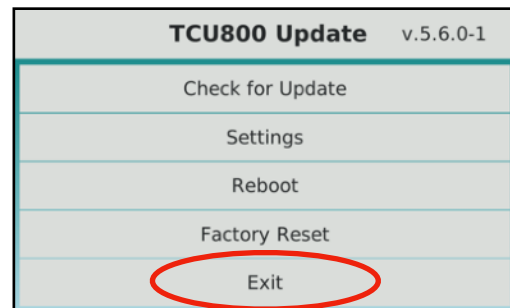
- 11 Tap **Exit** to return to the main screen.

The HOAs can now be returned to the AUTO position, and the TCU800 can will normal operation.
